**Flood Control Project Maintenance  
Levee Inspections**  
**LMA District Cover Sheet**  
**Spring 2016 Levee Inspection Results**

**Reclamation District No. 2031 Elliot**

**Levee Inspection Report By Mile - Spring 2016**

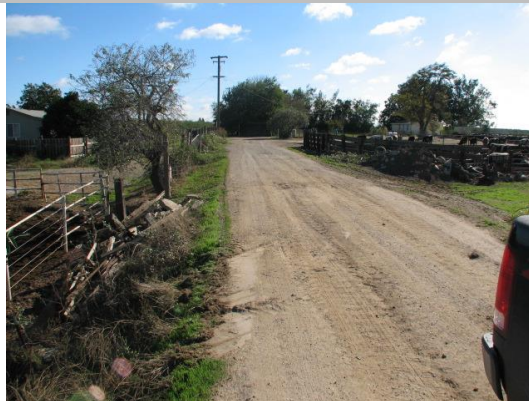
Photo 1 of 1 : SP\_2016\_RD2031\_307\_963\_20160229\_00038.jpg

LM Start	0.00	Rating **	M	Issue No.	963
LM End	0.06	Issue Type +	En	Location *	WS
Category	Earthen Levee			GPS Latitude/Longitude	
				Start	End
Item	Encroachments			37.710001 °	37.709951 °
				-121.155391 °	-121.156539 °
DWR ID	DWR_RD2031_01_s_2012_963				
Comment Code					
FE : Fence					
Inspector Comment					
Wooden and steel livestock fence and debris limit access to slope.

Fall 2009 photo looking upstream at beginning of unit 1. Water side to the left.

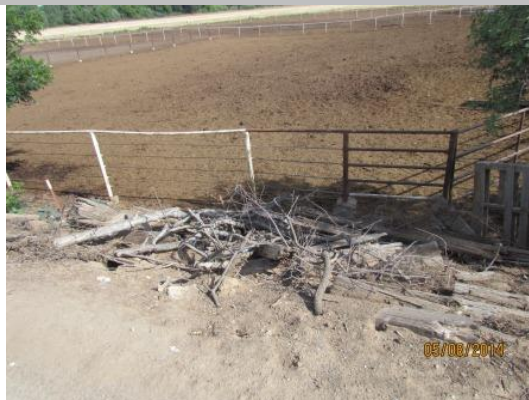
Photo 1 of 1 : SP\_2016\_RD2031\_307\_122\_20160229\_00034.jpg

LM Start	0.02	Rating **	U	Issue No.	122
LM End	0.02	Issue Type +	En	Location *	WS
Category	Earthen Levee			GPS Latitude/Longitude	
				Start	End
Item	Encroachments			37.710016 °	37.710016 °
				-121.155803 °	-121.155803 °
DWR ID	DWR_RD2031_01_s_2015_122				
Comment Code					
DE : Debris					
Inspector Comment

View of the pile of debris on the waterside levee slope.

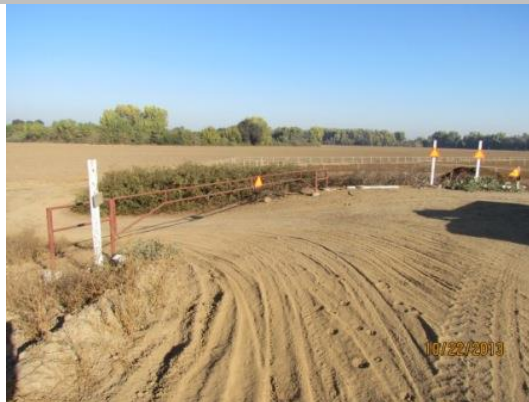
Photo 1 of 1 : SP\_2016\_RD2031\_307\_50\_20160229\_00024.jpg

LM Start	0.06	Rating **	M	Issue No.	50
LM End	0.06	Issue Type +	En	Location *	WS
Category	Earthen Levee			GPS Latitude/Longitude	
				Start	End
Item	Encroachments			37.709950 °	37.709950 °
				-121.156540 °	-121.156540 °
DWR ID	DWR_RD2031_01_f_2013_50				
Comment Code					
FE : Fence					
Inspector Comment					
Unpermitted gates at waterside levee hinge.

View of the gate at the waterside levee hinge.

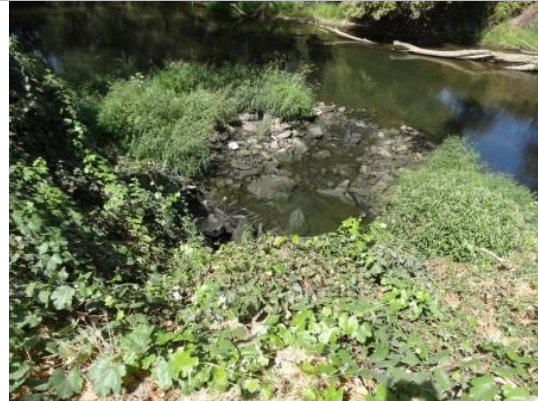
Photo 1 of 3 : SP\_2016\_RD2031\_307\_1\_20160229\_00001.jpg

Comment Code					
Inspector Comment					
08/28/2015: No significant change observed. 07/31/2014: No significant change observed. 09/10/2013: No significant change observed. 07/18/2012: No significant change observed. 08/18/2011: No significant change observed on site. Debris that blocks the irrigation outlet is visible. 10/19/2010: No significant change observed on site. Sloughing of the bank is occurring adjacent to an irrigation outlet structure. There is moderate to heavy vegetation along the bank that is well established. Broken chunks and slabs of concrete are used as rip rap and line the outside of the irrigation outlet structure. However, much of the rip rap along the slope is sloughing and could possibly lead to future slope instability. 08/05/2010: Recommended as a local maintenance issue, per CLRO. 08/20/2009: No major change observed since last visit; 1 inch fissure cracks developing on the slope; rip rap is showing signs of sloughing; recommend as local maintenance issue; site was previously rated "U". 2008: No change from previous year; irrigation outlet located on site; rip rap placed on river bank. 09/06/2007: Near agricultural diversion; only 3' landside height differential. [2015 Site ID:RD2031U01RM0.48]

Looking down at the site.

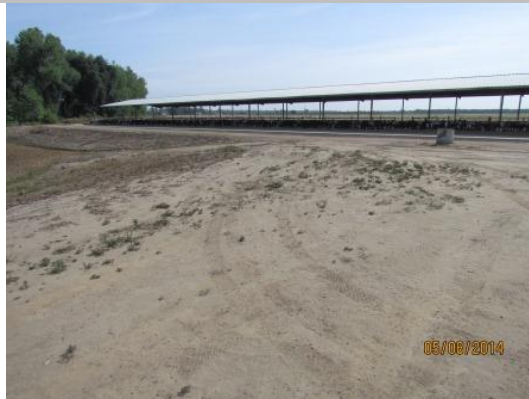
Photo 1 of 1 : SP\_2016\_RD2031\_307\_126\_20160229\_00035.jpg

LM Start	0.56	Rating **	M	Issue No.	126
LM End	0.56	Issue Type +	En	Location *	WS
Category	Earthen Levee			GPS Latitude/Longitude	
				Start	End
Item	Encroachments			37.703394 °	37.703394 °
				-121.159713 °	-121.159713 °
DWR ID	DWR_RD2031_01_s_2014_126				
Comment Code					
MA : Material					
Inspector Comment					
Levee built up with material from adjacent field. Unpermitted. The landowner has contacted CVFPB and started the permitting process.

View of the material placed on the waterside levee slope to build up the levee and increase the levee crown.

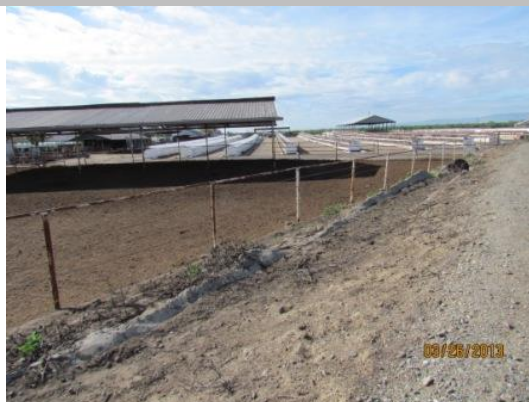
Photo 1 of 1 : SP\_2016\_RD2031\_307\_4\_20160229\_00008.jpg

LM Start	0.63	Rating **	M	Issue No.	4
LM End	0.72	Issue Type +	En	Location *	LS
Category	Earthen Levee			GPS Latitude/Longitude	
				Start	End
Item	Encroachments			37.702814 °	37.701875 °
				-121.160562 °	-121.161670 °
DWR ID	DWR_RD2031_01_s_2012_4				
Comment Code					
FE : Fence					
Inspector Comment

View of the fence at the landside levee toe.

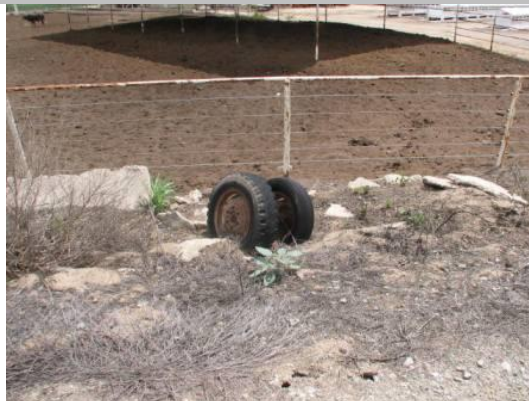
Photo 1 of 1 : SP\_2016\_RD2031\_307\_35\_20160229\_00017.jpg

LM Start	0.65	Rating **	M	Issue No.	35
LM End	0.65	Issue Type +	En	Location *	LS
Category	Earthen Levee			GPS Latitude/Longitude	
				Start	End
Item	Encroachments			37.702643 °	37.702643 °
				-121.160867 °	-121.160867 °
DWR ID	DWR_RD2031_01_s_2012_35				
Comment Code					
DE : Debris					
Inspector Comment					
Tractor wheels on slope of landside levee.

View of tractor wheels on landward slope. 05/02/2012

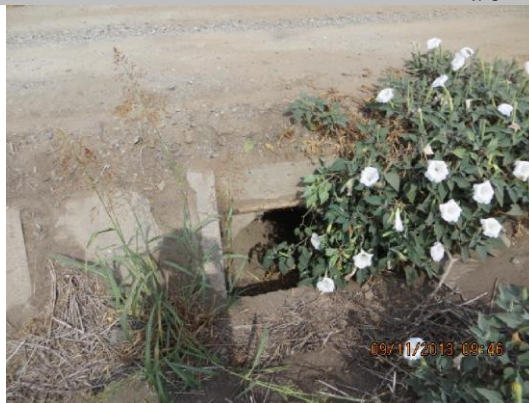
Photo 1 of 2 : UCIP\_SP\_2016\_20046\_33946.jpg

LM Start	0.72	Rating **	M	Issue No.	984	
LM End	0.72	Issue Type +	En	Location *	LS	
Category	Supplemental			GPS Latitude/Longitude		
				Start		End
Item	DWR UCIP Field Study			37.701912 °		37.701912 °
				-121.161642 °		-121.161642 °
DWR ID						
Comment Code						
Inspector Comment						
FS_ID:20046						
DS_ID:20440						
EP_NO: N/A						
Repair Type: Non-Urgent						
Crossing Status: Found						
UCIP Comments: Alfalfa valve on the WS toe is damaged.						
FIELD_STRUCT_DESC: 30-inch corrugated metal irrigation pipe through the levee 5.0-feet below the crown. Flashboard slots in concrete headwall on the landward side. Distribution box with alfalfa valve on the waterward side. Installed by USACE, 1966. Replaced a 30-inch pipe at same location.						
FS Date: 9/11/2013

Concrete headwall and pipe at concrete channel along landside shoulder of levee.

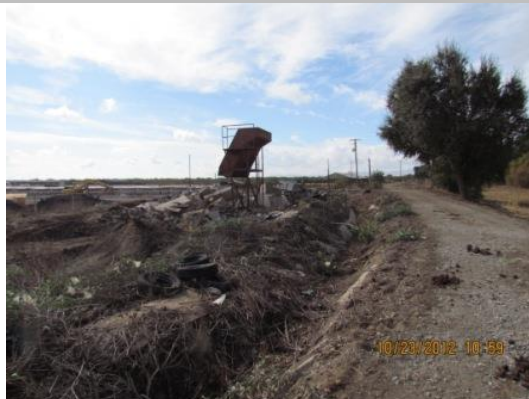
Photo 1 of 1 : SP\_2016\_RD2031\_307\_972\_20160229\_00040.jpg

LM Start	0.72	Rating **	M	Issue No.	972
LM End	0.76	Issue Type +	En	Location *	LS
Category	Earthen Levee			GPS Latitude/Longitude	
				Start	End
Item	Encroachments			37.701906 °	37.701370 °
				-121.161661 °	-121.161986 °
DWR ID	DWR_RD2031_01_s_2012_972				
Comment Code					
DT : Ditch					
Inspector Comment

View of the ditch on landside levee toe, facing downstream.

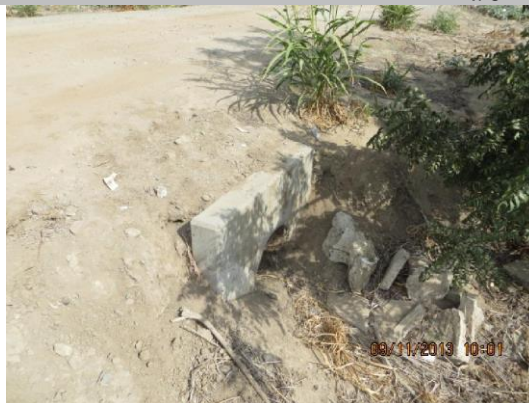
Photo 1 of 2 : UCIP\_SP\_2016\_20049\_33956.jpg

FS\_ID:20049  
DS\_ID:20443  
EP\_NO: N/A  
Repair Type: Non-Urgent  
Crossing Status: Found  
UCIP Comments: Pipe appears abandoned as WS slope is covered with soil. If abandoned, it should be done so properly.  
FIELD\_STRUCT\_DESC: 24-inch steel pipe through levee 2.0-feet below the crown. Concrete headwall on both sides of levee crown.  
FS Date: 9/11/2013

Open pipe and headwall on LS slope.

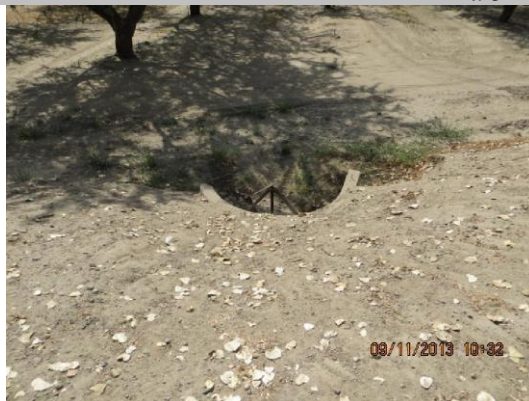
Photo 1 of 2 : UCIP\_SP\_2016\_47158\_74940.jpg

LM Start	0.92	Rating **	M	Issue No.	998
LM End	0.92	Issue Type +	En	Location *	CR
Category	Supplemental			GPS Latitude/Longitude	
				Start	End
Item	DWR UCIP Field Study			37.699692 °	37.699692 °
				-121.163977 °	-121.163977 °
DWR ID					
Comment Code					
Inspector Comment					
FS_ID:47158					
DS_ID:20444					
EP_NO: N/A					
Repair Type: Non-Urgent					
Crossing Status: Indicator Found					
UCIP Comments: Need site visit by UCIP--Concrete headwall present on landward side toe. Need to coordinate with owner to determine if this headwall is for 24-inch pipe or if the structure is part of drainage system that could run parallel to levee.					
FIELD_STRUCT_DESC: 24-inch pipe through levee 3.5 feet below crown. Flap gate on the waterward end.					
FS Date: 9/10/2013

Concrete structure located on landward side toe.

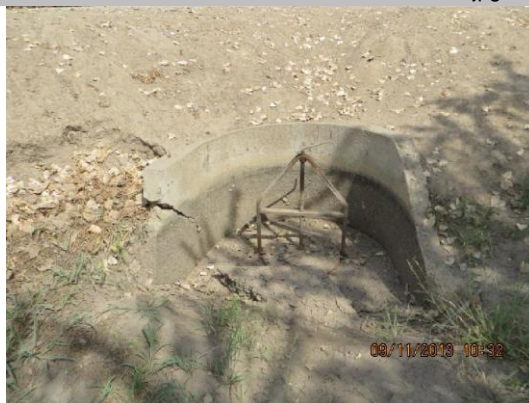
Photo 2 of 2 : UCIP\_SP\_2016\_47158\_74941.jpg

Front view of concrete structure located on landward toe.

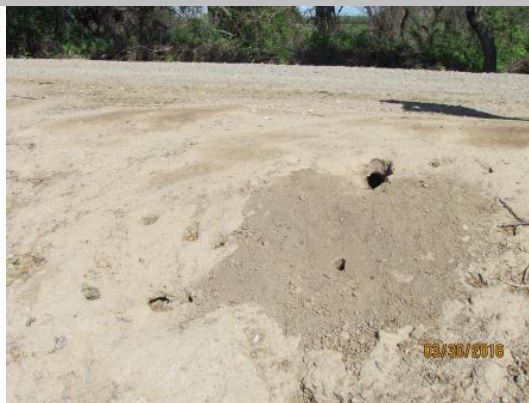
Photo 2 of 2 : SP\_2016\_RD2031\_307\_59\_20160412\_00082.jpg

Another view of the rodent hole on the landside levee slope.

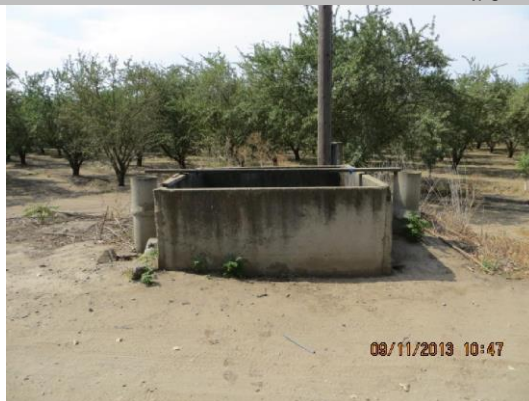
Photo 1 of 2 : UCIP\_SP\_2016\_20085\_34010.jpg

LM Start	1.27	Rating **	M	Issue No.	987
LM End	1.27	Issue Type +	En	Location *	WS
Category	Supplemental			GPS Latitude/Longitude	
				Start	End
Item	DWR UCIP Field Study			37.699480 °	37.699480 °
				-121.169850 °	-121.169850 °
DWR ID					
Comment Code					
Inspector Comment					
FS_ID:20085					
DS_ID:20445					
EP_NO: N/A					
Repair Type: Non-Urgent					
Crossing Status: Found					
UCIP Comments: Pipe corroded through at distribution box. Appears abandoned and should be done so properly.					
FIELD_STRUCT_DESC: 1 of 2: 12-inch steel pipe through the levee 3.3-feet below the crown. Pump missing from pile structure on the riverbank. Concrete distribution box on the landward side. Installed by USACE, 1966. Also included in 1968 O&M manual.					
FS Date: 9/11/2013

Concrete distribution box on LS shoulder.

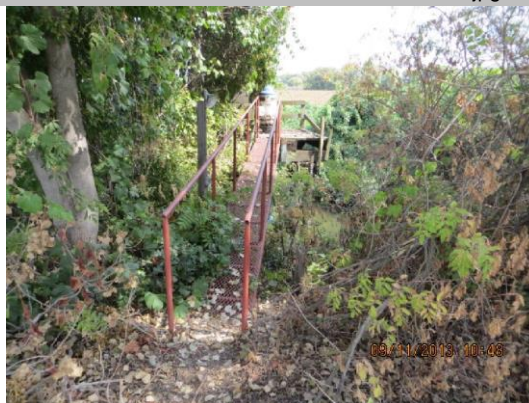
Photo 2 of 2 : UCIP\_SP\_2016\_20085\_34009.jpg

Pump on pier on WS slope.

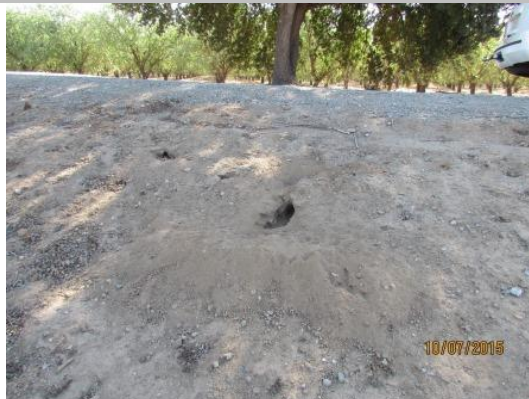
Photo 1 of 1 : SP\_2016\_RD2031\_307\_54\_20160229\_00029.jpg

LM Start	1.49	Rating **	M	Issue No.	54
LM End	1.49	Issue Type +	Ma	Location *	WS
Category	Earthen Levee			GPS Latitude/Longitude	
				Start	End
Item	Animal Control			37.699554 °	37.699554 °
				-121.173417 °	-121.173417 °
DWR ID	DWR_RD2031_01_f_2015_54				
Comment Code					
A1 : Exterminate rodents and backfill and compact or grout burrows.					
Inspector Comment

View of the multiple rodent holes on the waterside levee slope.

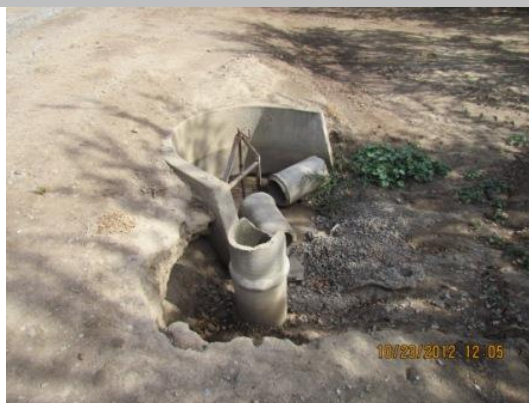
Photo 1 of 2 : SP\_2016\_RD2031\_307\_3\_20160229\_00006.jpg

LM Start	1.56	Rating **	U	Issue No.	3
LM End	1.56	Issue Type +	Ma	Location *	LS
Category	Earthen Levee			GPS Latitude/Longitude	
				Start	End
Item	Erosion / Bank Caving			37.698776 °	37.698776 °
				-121.174327 °	-121.174327 °
DWR ID	DWR_RD2031_01_s_2012_3				
Comment Code					
E1 : Note and monitor erosion site.					
Inspector Comment					
Erosion is active around the irrigation standpipe.

View of the erosion site on landside slope, facing upstream.

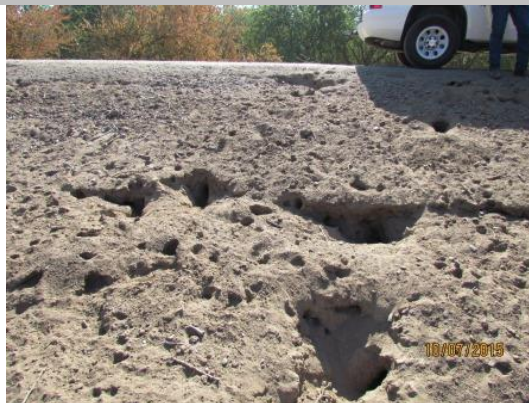
Photo 2 of 2 : SP\_2016\_RD2031\_307\_52\_20160229\_00027.jpg

LM Start	1.62	Rating **	U	Issue No.	52 (cont)	
LM End	1.62	Issue Type +	Ma	Location *	WS	
Category	Earthen Levee			GPS Latitude/Longitude		
				Start		End
Item	Animal Control			37.698334 °		37.698334 °
				-121.175176 °		-121.175176 °
DWR ID	DWR_RD2031_01_f_2013_52					
Comment Code						
A3 : No rodents visible, but rodent burrows visible; need to backfill and compact or grout burrows.						
Inspector Comment

Another view of the rodent holes on the waterside levee slope.

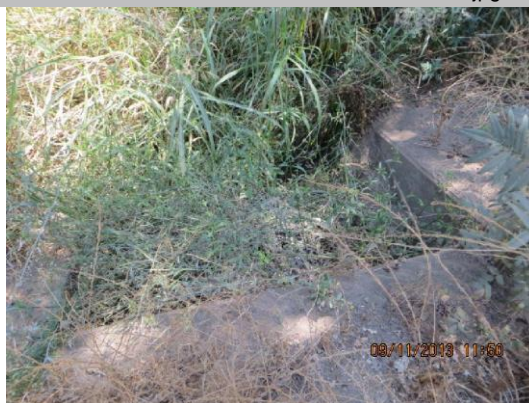
Photo 2 of 2 : UCIP\_SP\_2016\_41354\_34033.jpg

FS\_ID:41354  
DS\_ID:20470  
EP\_NO: N/A  
Repair Type: Non-Urgent  
Crossing Status: Found  
UCIP Comments: Silt buildup at inlet and outlet.  
FIELD\_STRUCT\_DESC: 1 of 2: 24-inch corrugated metal pipe through the levee 9.5-feet below the crown. Concrete "U"-shaped headwalls on both ends. Flap gate on the waterward end. Installed by USACE, 1966. Also included in the 1968 O&M manual.  
FS Date: 9/11/2013

Concrete headwall on LS toe.

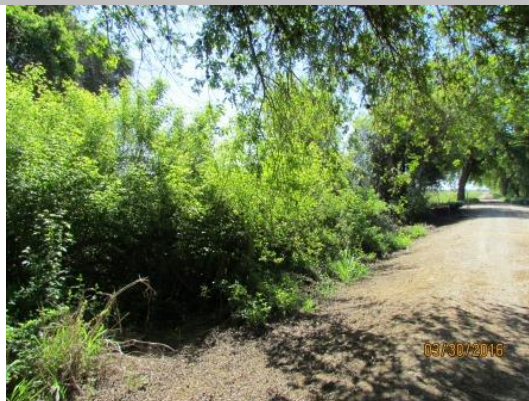
Photo 1 of 1 : SP\_2016\_RD2031\_307\_29\_20160412\_00083.jpg

LM Start	1.84	Rating **	U	Issue No.	29
LM End	1.84	Issue Type +	Ma	Location *	LS
Category	Earthen Levee			GPS Latitude/Longitude	
				Start	End
Item	Vegetation			37.696121 °	37.696121 °
				-121.177532 °	-121.177532 °
DWR ID	DWR_RD2031_01_s_2016_29				
Comment Code					
V2 : Remove the wild growth other than native grasses from the levee slopes.					
Inspector Comment

View of the tall vegetation on the landside levee slope.

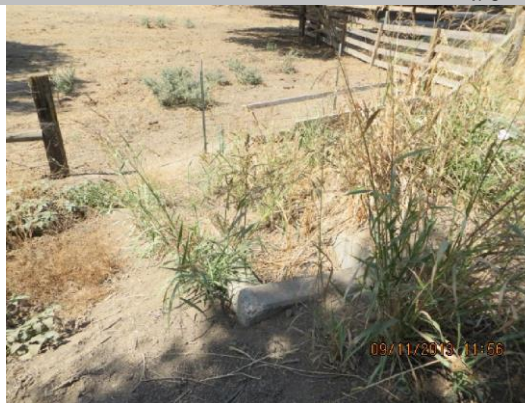
Photo 1 of 2 : UCIP\_SP\_2016\_20109\_34075.jpg

Concrete U-shaped headwall on WS toe.

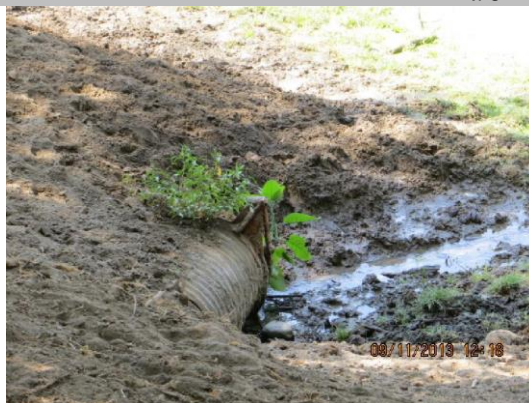
Photo 1 of 2 : UCIP\_SP\_2016\_43094\_39002.jpg

LM Start	2.45	Rating **	U	Issue No.	997
LM End	2.45	Issue Type +	En	Location *	LS
Category	Supplemental			GPS Latitude/Longitude	
				Start	End
Item	DWR UCIP Field Study			37.687949 °	37.687949 °
				-121.180305 °	-121.180305 °
DWR ID					
Comment Code					
Inspector Comment					
FS_ID:43094					
DS_ID:24669					
EP_NO: N/A					
Repair Type: Urgent					
Crossing Status: Found					
UCIP Comments: Flapgate partially blocked by soil on WS toe. Good candidate for video inspection.					
FIELD_STRUCT_DESC: 24-inch CMP stormdrain pipe through the levee at unknown depth. Flapgate on WS toe. Pipe may originate at concrete distribution box on LS toe.					
FS Date: 9/11/2013

Flapgate and pipe visible on WS toe.

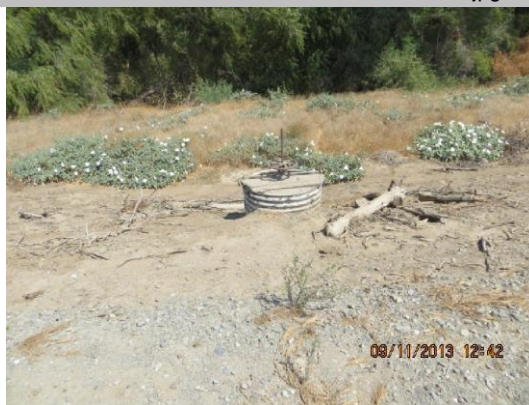
Photo 1 of 2 : UCIP\_SP\_2016\_20449\_34506.jpg

LM Start	3.08	Rating **	M	Issue No.	990
LM End	3.08	Issue Type +	En	Location *	WS
Category	Supplemental			GPS Latitude/Longitude	
				Start	End
Item	DWR UCIP Field Study			37.688297 °	37.688297 °
				-121.190865 °	-121.190865 °
DWR ID					
Comment Code					
Inspector Comment					
FS_ID:20449					
DS_ID:20451					
EP_NO: N/A					
Repair Type: Non-Urgent					
Crossing Status: Found					
UCIP Comments: Pipe appears to be abandoned and if so should be done so properly.					
FIELD_STRUCT_DESC: 24-inch corrugated metal pipe through levee 14.0 feet below crown. Slide gate in 36-inch corrugated metal pipe riser on the waterward slope. Originally included in the 1968 O&M manual.					
FS Date: 9/11/2013

Slide gate in CMP riser on WS slope.

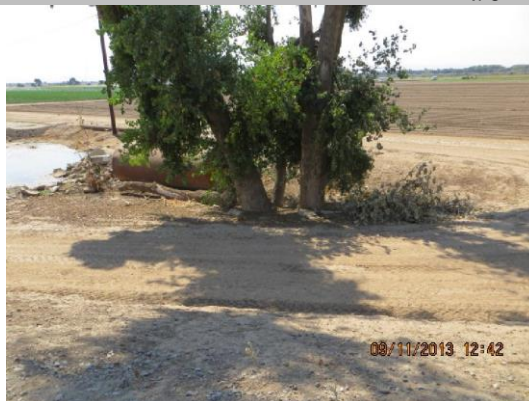
Photo 2 of 2 : UCIP\_SP\_2016\_20449\_34505.jpg

LM Start	3.08	Rating **	M	Issue No.	990 (cont)	
LM End	3.08	Issue Type +	En	Location *	WS	
Category	Supplemental			GPS Latitude/Longitude		
				Start	End	
Item	DWR UCIP Field Study			37.688297 °	37.688297 °	
				-121.190865 °	-121.190865 °	
DWR ID						
Comment Code						
Inspector Comment						
FS_ID:20449						
DS_ID:20451						
EP_NO: N/A						
Repair Type: Non-Urgent						
Crossing Status: Found						
UCIP Comments: Pipe appears to be abandoned and if so should be done so properly.						
FIELD_STRUCT_DESC: 24-inch corrugated metal pipe through levee 14.0 feet below crown. Slide gate in 36-inch corrugated metal pipe riser on the waterward slope. Originally included in the 1968 O&M manual.						
FS Date: 9/11/2013

Pipe not visible on LS toe.

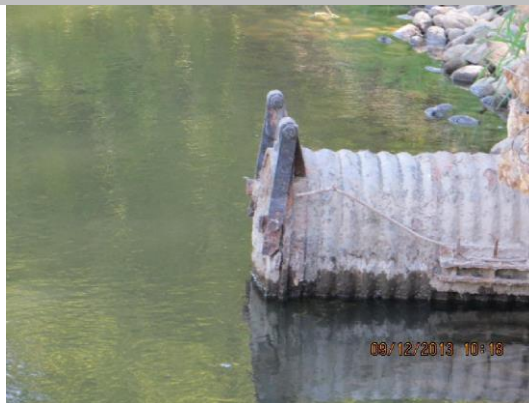
Photo 2 of 2 : UCIP\_SP\_2016\_23064\_39199.jpg

LM Start	3.66	Rating **	M	Issue No.	995
LM End	3.66	Issue Type +	En	Location *	LS
Category	Supplemental			GPS Latitude/Longitude	
				Start	End
Item	DWR UCIP Field Study			37.689900 °	37.689900 °
				-121.198319 °	-121.198319 °
DWR ID					
Comment Code					
Inspector Comment					
FS_ID:23064 DS_ID:20478 EP_NO: N/A Repair Type: Non-Urgent Crossing Status: Found UCIP Comments: Good candidate for video inspection. FIELD_STRUCT_DESC: 24-inch CMP drainpipe through levee 5.5 feet below crown. Flapgate visilbe at WS toe. Originally included in the 1968 O&M manual. FS Date: 9/12/2013

CMP pipe and flapgate visible at WS toe.

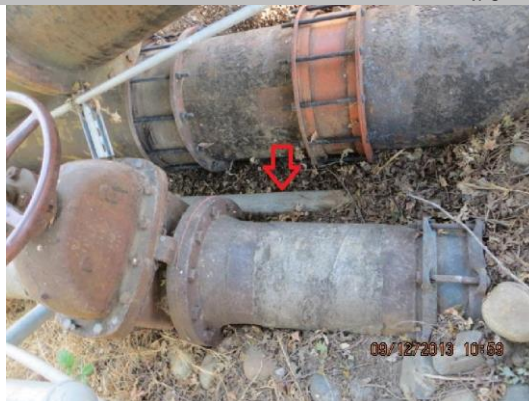
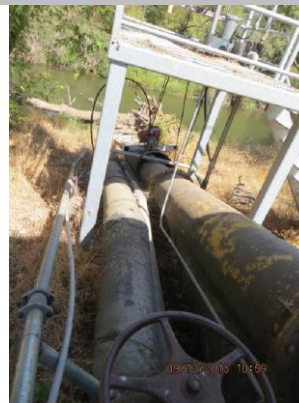
LM Start	3.69	Rating **	M	Issue No.	992
LM End	3.69	Issue Type +	En	Location *	LS
Category	Supplemental			GPS Latitude/Longitude	
				Start	End
Item	DWR UCIP Field Study			37.689742 °	37.689742 °
				-121.198778 °	-121.198778 °
DWR ID					
Comment Code					
Inspector Comment					
FS_ID:22843					
DS_ID:24672					
EP_NO: N/A					
Repair Type: Non-Urgent					
Crossing Status: Found					
UCIP Comments: No permit identified for this possible crossing.					
FIELD_STRUCT_DESC: 4-inch steel irrigation line through the levee at unknown depth. Pipe visible between larger irrigation pipes below slant pump on WS slope.					
FS Date: 9/12/2013

Pipe visible between larger irrigation pipes below slant pump on WS slope.

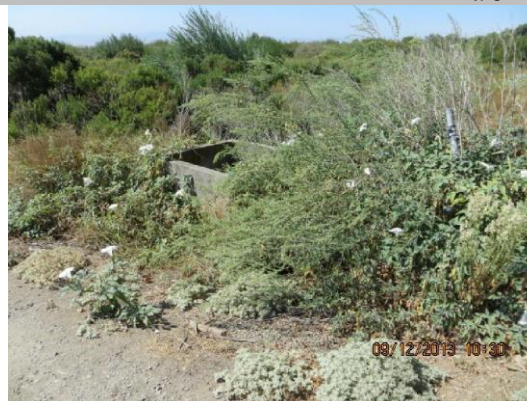
Photo 1 of 2 : UCIP\_SP\_2016\_20667\_34750.jpg

LM Start	3.69	Rating **	M	Issue No.	991
LM End	3.69	Issue Type +	En	Location *	LS
Category	Supplemental			GPS Latitude/Longitude	
				Start	End
Item	DWR UCIP Field Study			37.689739 °	37.689739 °
				-121.198790 °	-121.198790 °
DWR ID					
Comment Code					
Inspector Comment					
FS_ID:20667 DS_ID:20456 EP_NO: N/A Repair Type: Non-Urgent Crossing Status: Found UCIP Comments: Siphon breaker missing from LS shoulder. Fish screen and pipe end covered in debris that may cause damage to pipe. FIELD_STRUCT_DESC: 1 of 2: 20-inch steel irrigation pipe through levee 3.9 feet below crown. Slant pump in pump house mounted on piles on the berm. Siphon breaker in corrugated metal pipe riser on the landward shoulder. Service pole on the landward slope. 5'X5' concrete distribution box on LS toe with flapgate. Originally included in the 1968 O&M manual. FS Date: 9/12/2013

Concrete distribution box on LS slope.

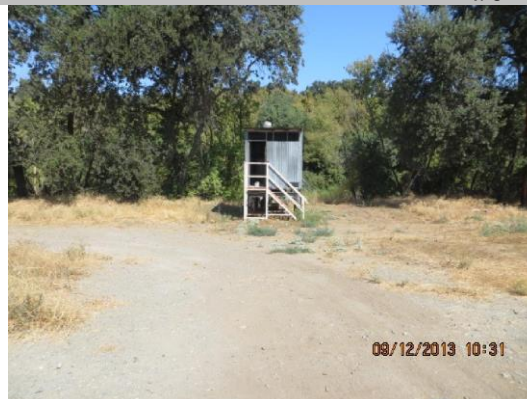
Photo 2 of 2 : UCIP\_SP\_2016\_20667\_34749.jpg

Slant pump in pumphouse on WS berm.

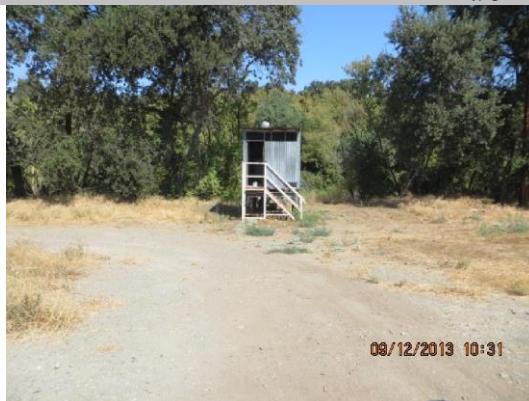
Photo 1 of 2 : UCIP\_SP\_2016\_22845\_39021.jpg

LM Start	3.69	Rating **	M	Issue No.	993
LM End	3.69	Issue Type +	En	Location *	LS
Category	Supplemental			GPS Latitude/Longitude	
				Start	End
Item	DWR UCIP Field Study			37.689757 °	37.689757 °
				-121.198804 °	-121.198804 °
DWR ID					
Comment Code					
Inspector Comment					
FS_ID:22845					
DS_ID:24671					
EP_NO: N/A					
Repair Type: Non-Urgent					
Crossing Status: Found					
UCIP Comments: No permit identified for this possible crossing.					
FIELD_STRUCT_DESC: 2.5-inch galvanized iron irrigation line through the levee at unknown depth. Submersible pump at WS slope.					
FS Date: 9/12/2013

Pipe visible on WS of pumphouse.

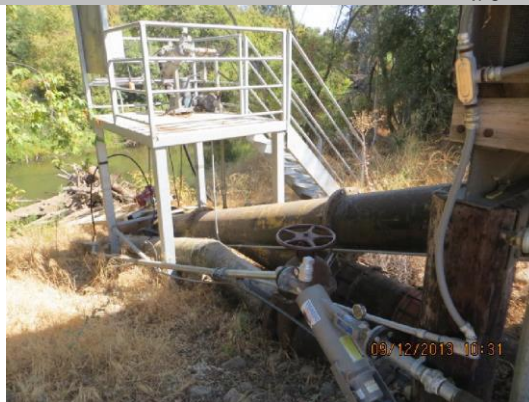
Photo 2 of 2 : UCIP\_SP\_2016\_22845\_39020.jpg

Pipe and appurtances visible on downstream side of and next to larger irrigation pipe.

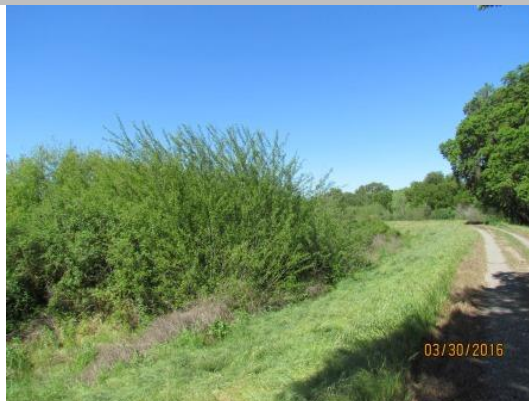
Photo 1 of 3 : SP\_2016\_RD2031\_307\_33\_20160412\_00088.jpg

LM Start	<b>3.74</b>	Rating **	U	Issue No.	<b>33 (cont)</b>
LM End	<b>4.25</b>	Issue Type +	Ma	Location *	LS

View of the tall vegetation on the landside levee slope and toe.

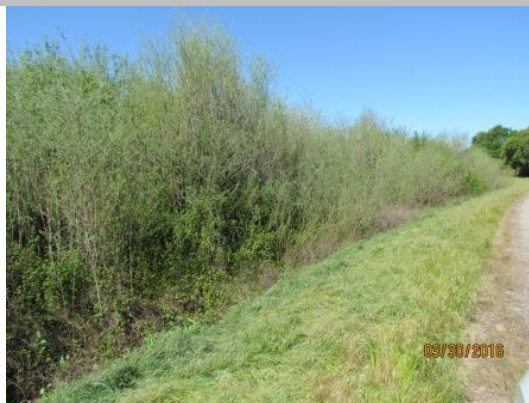
Photo 2 of 3 : SP\_2016\_RD2031\_307\_33\_20160412\_00087.jpg

Typical view of the tall vegetation on the landside levee slope and toe in this area.

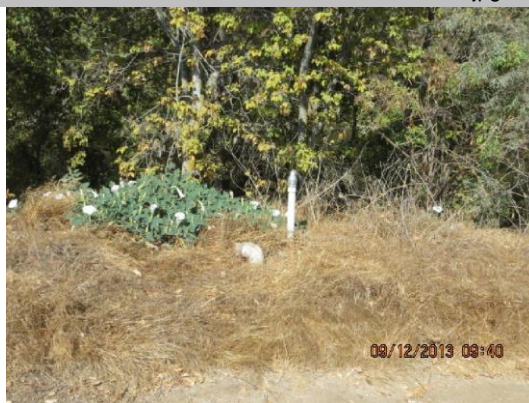
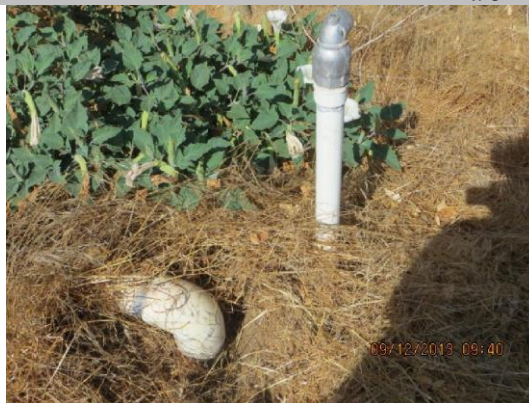
LM Start	4.40	Rating **	M	Issue No.	994
LM End	4.40	Issue Type +	En	Location *	LS
Category	Supplemental			GPS Latitude/Longitude	
				Start	End
Item	DWR UCIP Field Study			37.686500 °	37.686500 °
				-121.207900 °	-121.207900 °
DWR ID					
Comment Code					
Inspector Comment					
FS_ID:22846 DS_ID:24673 EP_NO: N/A Repair Type: Non-Urgent Crossing Status: Found UCIP Comments: No permit identified for this possible crossing. FIELD_STRUCT_DESC: 4-inch galvanized iron irrigation line visible on WS shoulder. May go through the levee at unknown depth. Vent on WS shoulder. FS Date: 9/12/2013

Pipe and vent visible on WS shoulder.

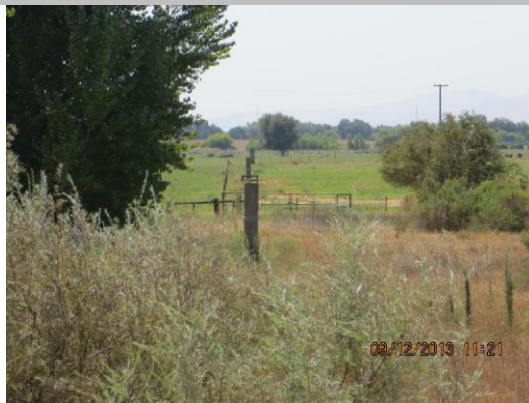
Photo 1 of 2 : UCIP\_SP\_2016\_20688\_34799.jpg

LM Start	4.97	Rating **	M	Issue No.	983
LM End	4.97	Issue Type +	En	Location *	LS
Category	Supplemental			GPS Latitude/Longitude	
				Start	End
Item	DWR UCIP Field Study			37.680103 °	37.680103 °
				-121.212016 °	-121.212016 °
DWR ID					
Comment Code					
Inspector Comment					
FS_ID:20688 DS_ID:20461 EP_NO: N/A Repair Type: Non-Urgent Crossing Status: Found UCIP Comments: CMP riser on WS slope is missing lid and may be a hazard. FIELD_STRUCT_DESC: 36-inch corrugated metal irrigation pipe through levee 11-feet below crown. Slide gate in 48-inch CMP riser on the waterward slope. 5'X5' Concrete distribution box 10 feet from the waterward toe. Underground irrigation system on the landside with concrete standpipes visible in field. Originally included in the 1968 O&M manual. FS Date: 9/12/2013

Concrete standpipes visible in field off LS toe.

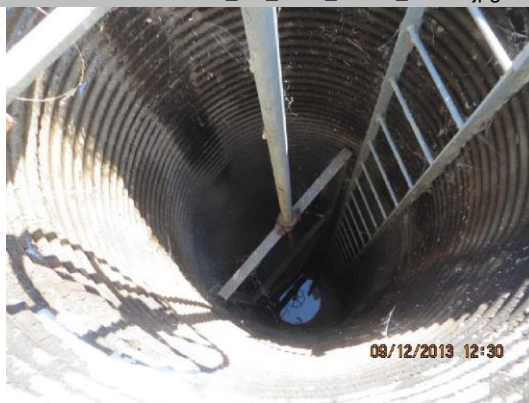
Photo 1 of 2 : UCIP\_SP\_2016\_20708\_34834.jpg

LM Start	0.24	Rating **	M	Issue No.	967
LM End	0.24	Issue Type +	En	Location *	WS
Category	Supplemental			GPS Latitude/Longitude	
				Start	End
Item	DWR UCIP Field Study			37.658595 °	37.658595 °
				-121.234410 °	-121.234410 °
DWR ID					
Comment Code					
Inspector Comment					
FS_ID:20708 DS_ID:20484 EP_NO: N/A Repair Type: Non-Urgent Crossing Status: Found UCIP Comments: Inlet filled with soil, and CMP riser on WS slope needs lid as it may be a hazard. FIELD_STRUCT_DESC: 48-inch corrugated metal pipe through levee 22.8 feet below crown. Slide gate in 5-foot diameter corrugated metal pipe riser on the waterward slope. Concrete "U" headwall on both ends. Flap gate on the waterward end. Originally included in the 1968 O&M manual. FS Date: 9/17/2013

Slide gate in CMP riser on WS slope.

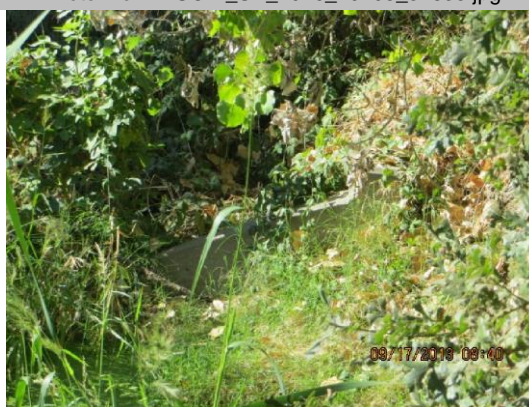
Photo 2 of 2 : UCIP\_SP\_2016\_20708\_34833.jpg

Concrete headwall on LS toe at edge of pond.

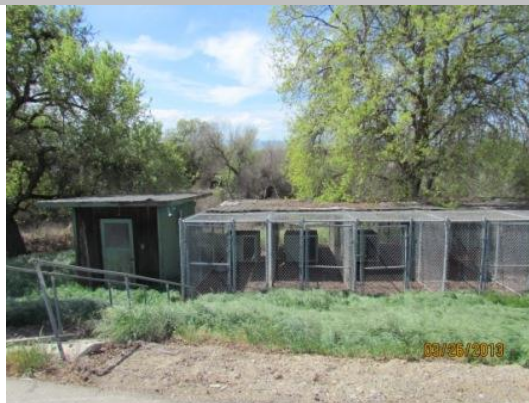
Photo 1 of 1 : SP\_2016\_RD2031\_308\_8\_20160229\_00005.jpg

LM Start	1.28	Rating **	A/W	Issue No.	8
LM End	1.28	Issue Type +	En	Location *	WS
Category	Earthen Levee			GPS Latitude/Longitude	
				Start	End
Item	Encroachments			37.649918 °	37.649918 °
				-121.221913 °	-121.221913 °
DWR ID	DWR_RD2031_02_s _ 2013_8				
Comment Code					
BU : Building					
Inspector Comment					
Permit No. 5793

View of the structure at the waterside levee toe.

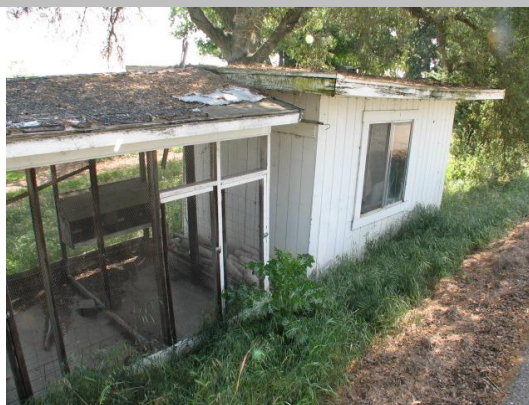
Photo 1 of 1 : SP\_2016\_RD2031\_308\_4\_20160229\_00004.jpg

LM Start	1.35	Rating **	U	Issue No.	4
LM End	1.35	Issue Type +	En	Location *	LS
Category	Earthen Levee			GPS Latitude/Longitude	
				Start	End
Item	Encroachments			37.648898 °	37.648898 °
				-121.221621 °	-121.221621 °
DWR ID	DWR_RD2031_02_s _ 2012_4				
Comment Code					
BU : Building					
Inspector Comment

Small structure on levee slope.

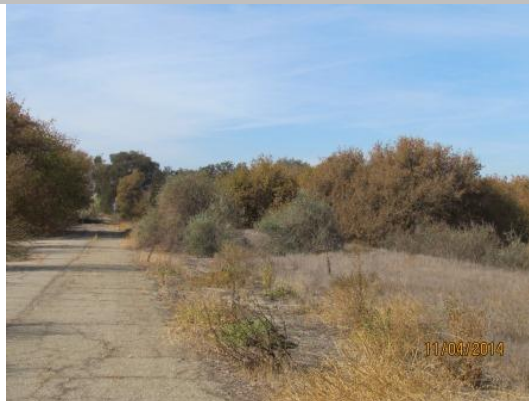
Photo 1 of 1 : SP\_2016\_RD2031\_308\_21\_20160229\_00007.jpg

LM Start	2.14	Rating **	M	Issue No.	21
LM End	2.14	Issue Type +	Ma	Location *	CR
Category	Earthen Levee			GPS Latitude/Longitude	
				Start	End
Item	Vegetation			37.640632 °	37.640632 °
				-121.221539 °	-121.221539 °
DWR ID	DWR_RD2031_02_f_2014_21				
Comment Code					
V2 : Remove the wild growth other than native grasses from the levee slopes.					
Inspector Comment

View of overgrown vegetation on the levee crown.

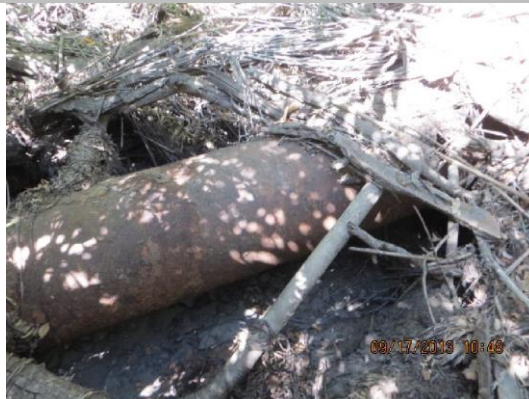
Photo 1 of 2 : UCIP\_SP\_2016\_20713\_34838.jpg

Comment Code					
Inspector Comment					
FS_ID:20713 DS_ID:20490 EP_NO: 11758 Repair Type: Non-Urgent Crossing Status: Found UCIP Comments: Pipe rusted through and failing at WS toe. Good indicator of internal condition of pipe. Good candidate for video inspection. FIELD_STRUCT_DESC: 24-inch corrugated metal gravity drain pipe through levee 17.0 feet below crown. 20-inch steel pipe and 1.25-inch galvanized conduit sleeved through pipe. Annular space has been pressure grouted. 24-inch pipe originally included in the 1968 O&M manual. Slide gate in 48-inch CMP riser on LS slope. 36-inch concrete standpipe at LS toe with pump on 48-inch steel standpipe. 20-inch and 1.5-inch pipes installed under Permit No. 11758, 1976. FS Date: 9/17/2013

Pipe visible on LS toe.

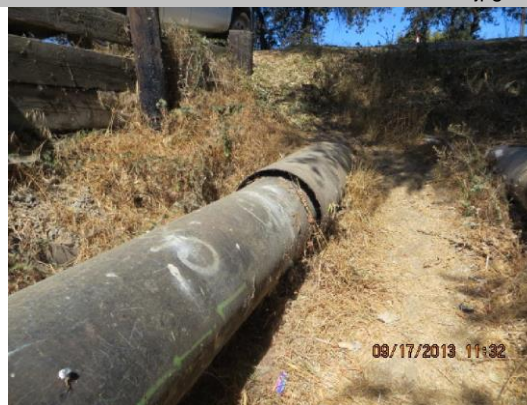
Photo 1 of 2 : UCIP\_SP\_2016\_20719\_34860.jpg

LM Start	3.21	Rating **	M	Issue No.	970
LM End	3.21	Issue Type +	En	Location *	LS
Category	Supplemental			GPS Latitude/Longitude	
				Start	End
Item	DWR UCIP Field Study			37.638185 °	37.638185 °
				-121.202906 °	-121.202906 °
DWR ID					
Comment Code					
Inspector Comment					
FS_ID:20719 DS_ID:20492 EP_NO: N/A Repair Type: Non-Urgent Crossing Status: Found UCIP Comments: Annular space between 20-inch and 24-inch pipe not grouted. FIELD_STRUCT_DESC: 24-inch steel pipe through levee 8.0 feet below crown. Pump on pile structure in river. 20-inch steel pipe sleeved through 24-inch. 4'X11' concrete distribution box on LS toe. 2-inch electrical conduit at same location. Originally included in the 1968 O&M manual. FS Date: 9/17/2013

24-inch with 20-inch sleeved through it.

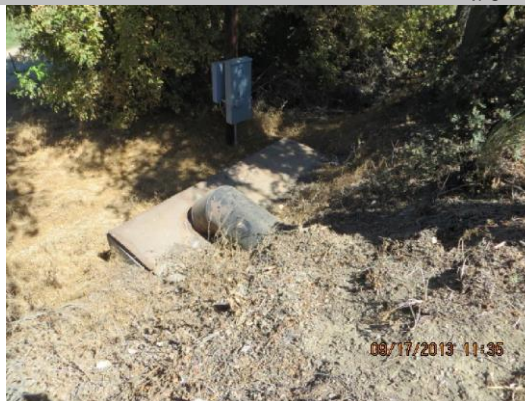
Photo 2 of 2 : UCIP\_SP\_2016\_20719\_34859.jpg

Concrete distribution box on LS slope.

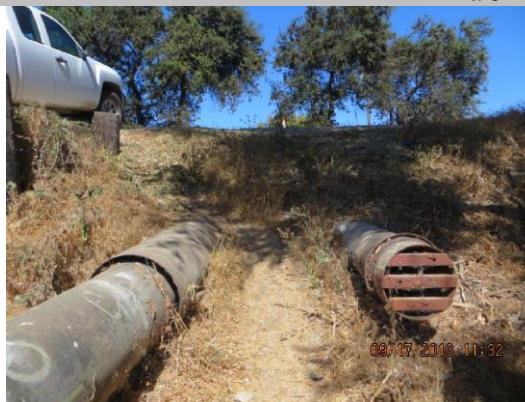
Photo 1 of 2 : UCIP\_SP\_2016\_20718\_34856.jpg

LM Start	3.22	Rating **	M	Issue No.	969
LM End	3.22	Issue Type +	En	Location *	LS
Category	Supplemental			GPS Latitude/Longitude	
				Start	End
Item	DWR UCIP Field Study			37.638186 °	37.638186 °
				-121.202895 °	-121.202895 °
DWR ID					
Comment Code					
Inspector Comment					
FS_ID:20718					
DS_ID:20493					
EP_NO: N/A					
Repair Type: Non-Urgent					
Crossing Status: Found					
UCIP Comments: Pipe appears abandoned and if so should be done so properly.					
FIELD_STRUCT_DESC: 16-inch steel pipe through levee 7.5 feet below crown. Pump on pile structure in river. 4'X11' concrete distribution box on LS slope. 6'X6' concrete distribution box off LS toe. Originally included in the 1968 O&M manual.					
FS Date: 9/17/2013

Pipe at right-abandoned.

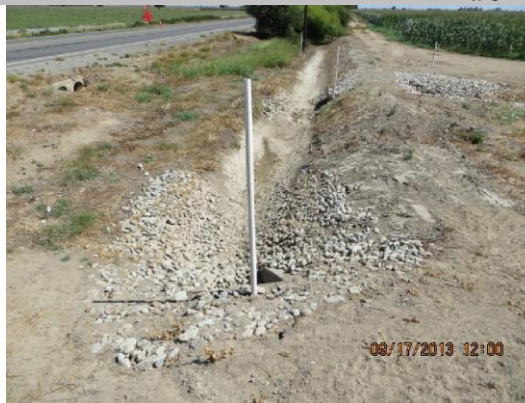
Photo 1 of 2 : UCIP\_SP\_2016\_43095\_34886.jpg

LM Start	3.84	Rating **	U	Issue No.	974
LM End	3.84	Issue Type +	En	Location *	LS
Category	Supplemental			GPS Latitude/Longitude	
				Start	End
Item	DWR UCIP Field Study			37.637924°	37.637924°
				-121.191600°	-121.191600°
DWR ID					
Comment Code					
Inspector Comment					
FS_ID:43095 DS_ID:20496 EP_NO: N/A Repair Type: Urgent Crossing Status: Found UCIP Comments: Minor debris blocking closure of flapgate on WS toe. FIELD_STRUCT_DESC: 24-inch corrugated metal pipe through levee 11.0 feet below crown. Concrete "U" headwall on each end. Flap gate on the waterward end. Originally included in the 1968 O&M manual. FS Date: 9/17/2013

Concrete headwall on LS toe.

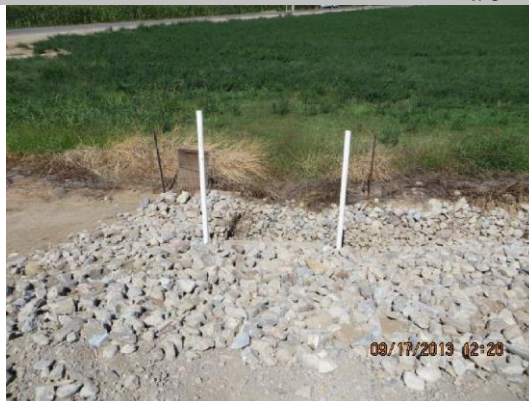
Photo 1 of 2 : UCIP\_SP\_2016\_22872\_39036.jpg

LM Start	4.70	Rating **	M	Issue No.	972
LM End	4.70	Issue Type +	En	Location *	WS
Category	Supplemental			GPS Latitude/Longitude	
				Start	End
Item	DWR UCIP Field Study			37.630815 °	37.630815 °
				-121.182416 °	-121.182416 °
DWR ID					
Comment Code					
Inspector Comment					
FS_ID:22872					
DS_ID:24676					
EP_NO: N/A					
Repair Type: Non-Urgent					
Crossing Status: Found					
UCIP Comments: No permit identified for this crossing.					
FIELD_STRUCT_DESC: 16-inch PVC irrigation pipe through the levee					
6-feet below the crown. Headwall on LS toe.					
FS Date: 9/17/2013

Concrete headwall at outlet on LS toe.

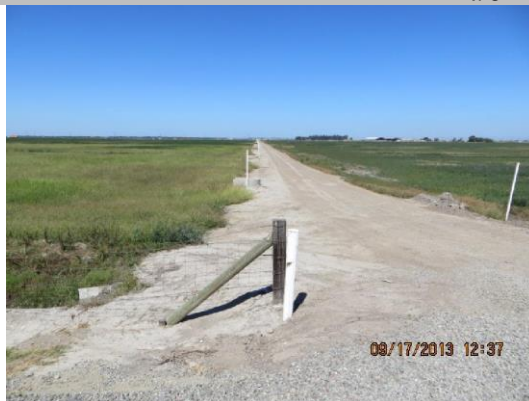
Photo 1 of 2 : UCIP\_SP\_2016\_22873\_39038.jpg

LM Start	5.63	Rating **	M	Issue No.	973
LM End	5.63	Issue Type +	En	Location *	WS
Category	Supplemental			GPS Latitude/Longitude	
				Start	End
Item	DWR UCIP Field Study			37.630779 °	37.630779 °
				-121.165402 °	-121.165402 °
DWR ID					
Comment Code					
Inspector Comment					
FS_ID:22873 DS_ID:24677 EP_NO: N/A Repair Type: Non-Urgent Crossing Status: Found UCIP Comments: No permit identified for this crossing. FIELD_STRUCT_DESC: 24-inch PVC irrigation pipeline through levee 5.0-feet below crown. Slide gate at waterward shoulder. 6-inch steel riser on WS shoulder. FS Date: 9/17/2013

Concrete turnouts visible off LS toe along road.

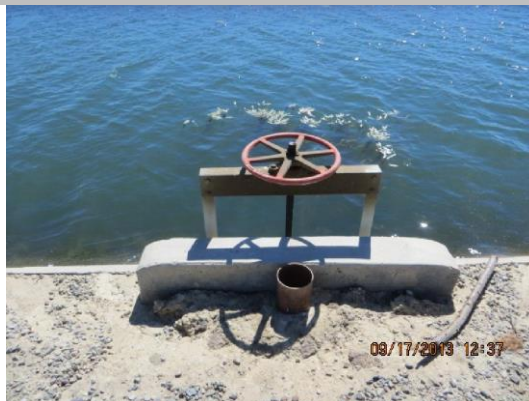
Photo 2 of 2 : UCIP\_SP\_2016\_22873\_39037.jpg

Slide gate and vent at concrete headwall on canal at WS shoulder.

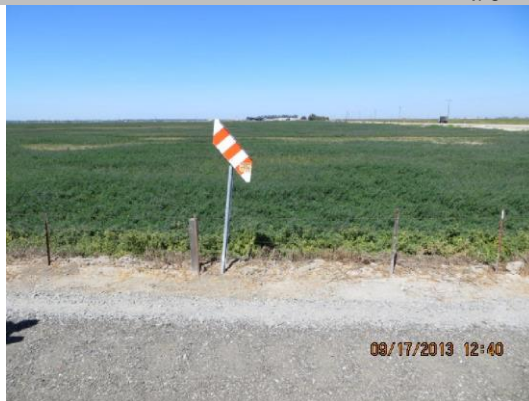
Photo 1 of 2 : UCIP\_SP\_2016\_20745\_34961.jpg

LM Start	5.93	Rating **	M	Issue No.	971
LM End	5.93	Issue Type +	En	Location *	WS
Category	Supplemental			GPS Latitude/Longitude	
				Start	End
Item	DWR UCIP Field Study			37.630760 °	37.630760 °
				-121.159951 °	-121.159951 °
DWR ID					
Comment Code					
Inspector Comment					
FS_ID:20745 DS_ID:20503 EP_NO: N/A Repair Type: Non-Urgent Crossing Status: Found UCIP Comments: Gasline may not have enough cover. FIELD_STRUCT_DESC: 8-inch gas line through the levee 1.0-foot below the crown. Originally included in the 1968 O&M manual. Sign on LS toe, pipe visible at canal. FS Date: 9/17/2013

Gasline marker on LS toe.

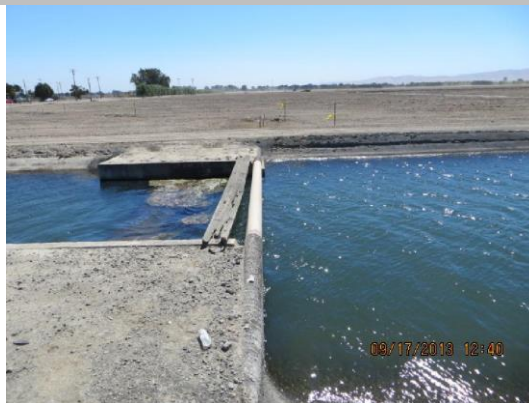
Photo 2 of 2 : UCIP\_SP\_2016\_20745\_34960.jpg

LM Start	<b>5.93</b>	Rating **	M	Issue No.	<b>971 (cont)</b>
LM End	<b>5.93</b>	Issue Type +	En	Location *	WS

Gasline visible at crossing.
